The 156-tonne GIMLI GLIDER

It's the 20th anniversary of aviation's most famous deadstick landing.

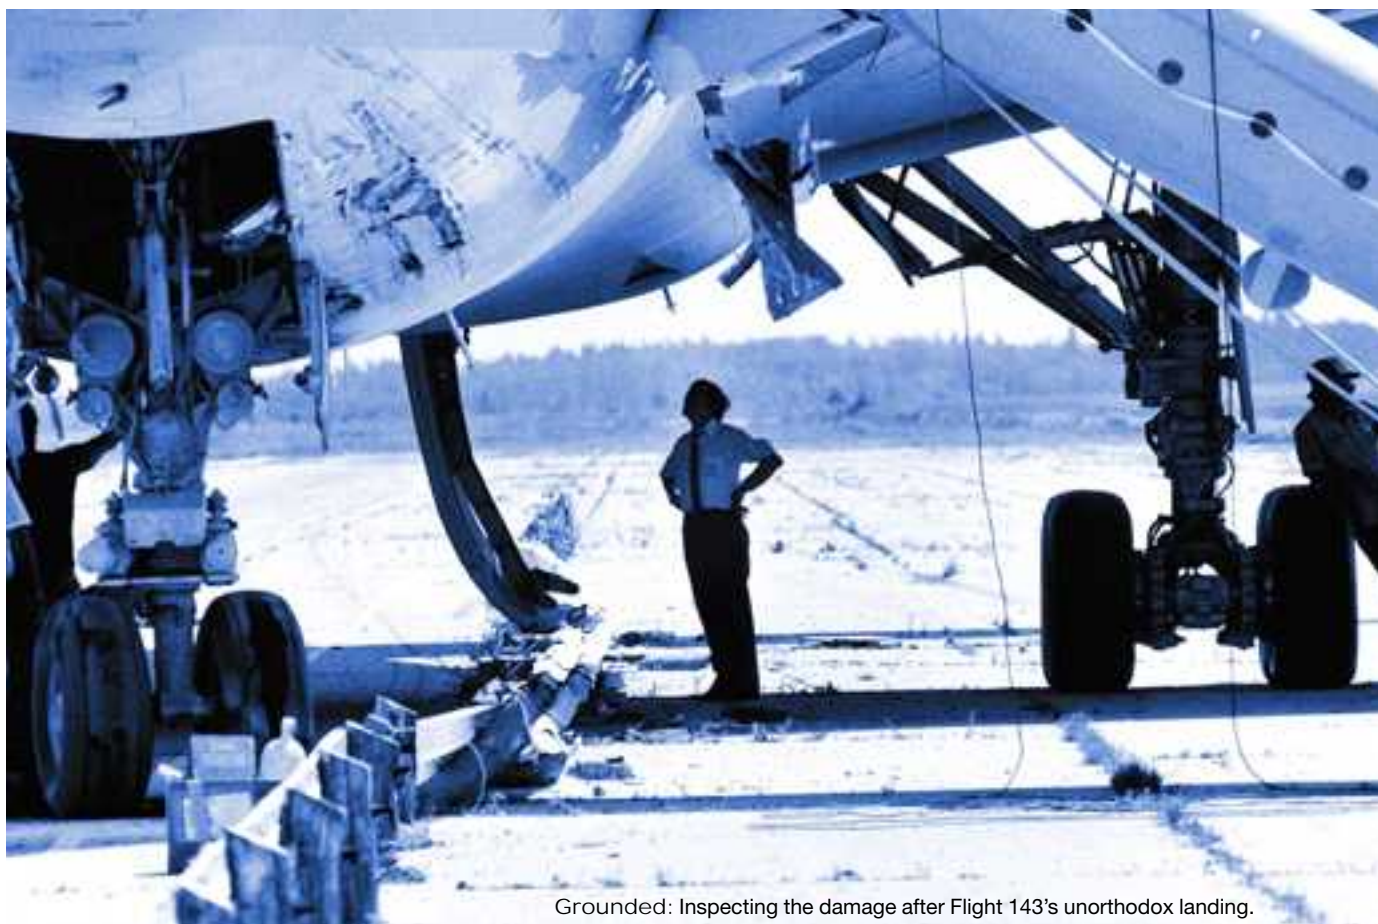
Grounded: Inspecting the damage after Flight 143's unorthodox landing.

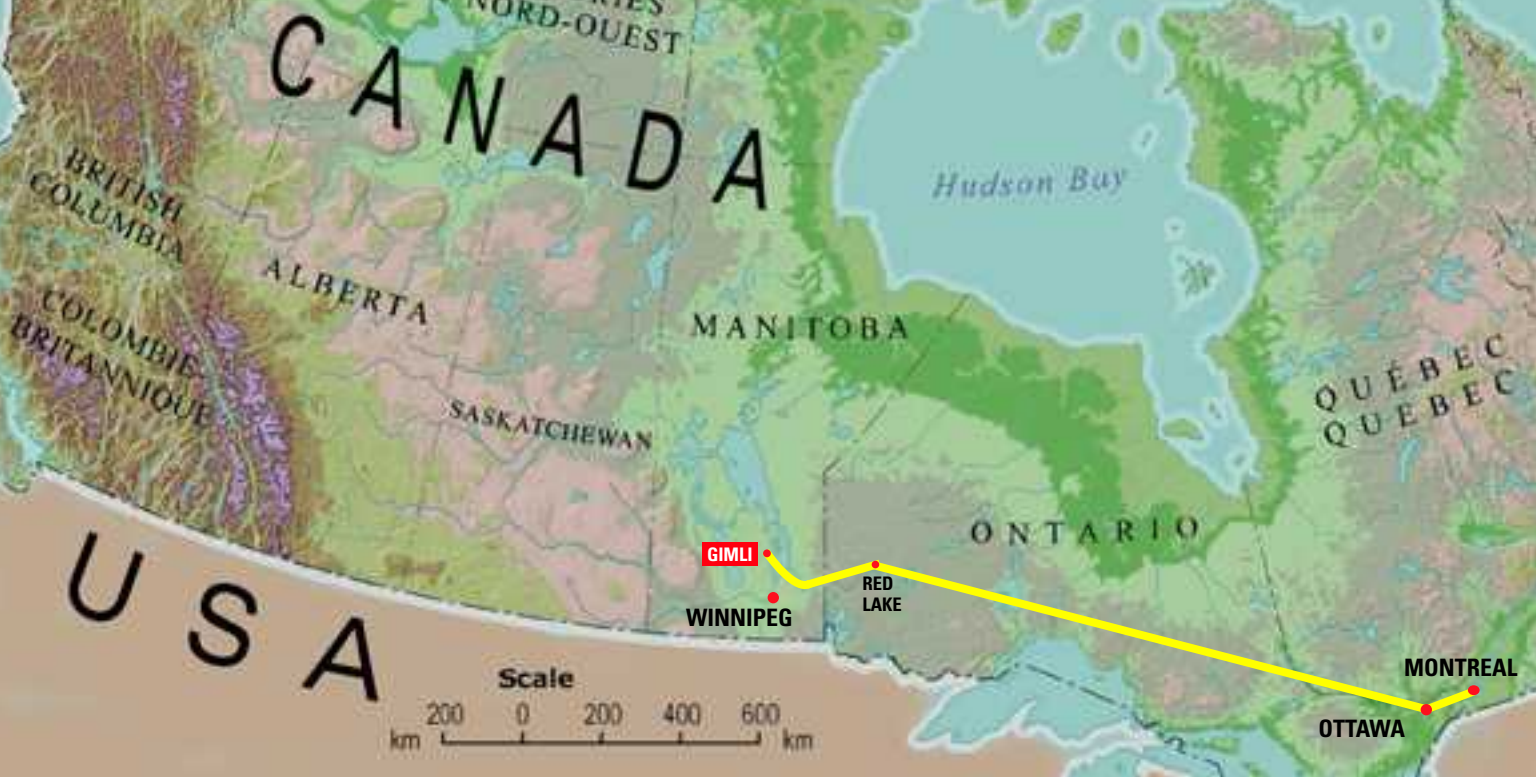
Cut short Travelling from Montreal to Edmonton via Ottawa, Flight 143 was forced to divert to Winnipeg because of a fuel shortage that led to the loss of both engines. When it became apparent the aircraft would not reach Winnipeg, the pilots changed course and headed to Gimli.

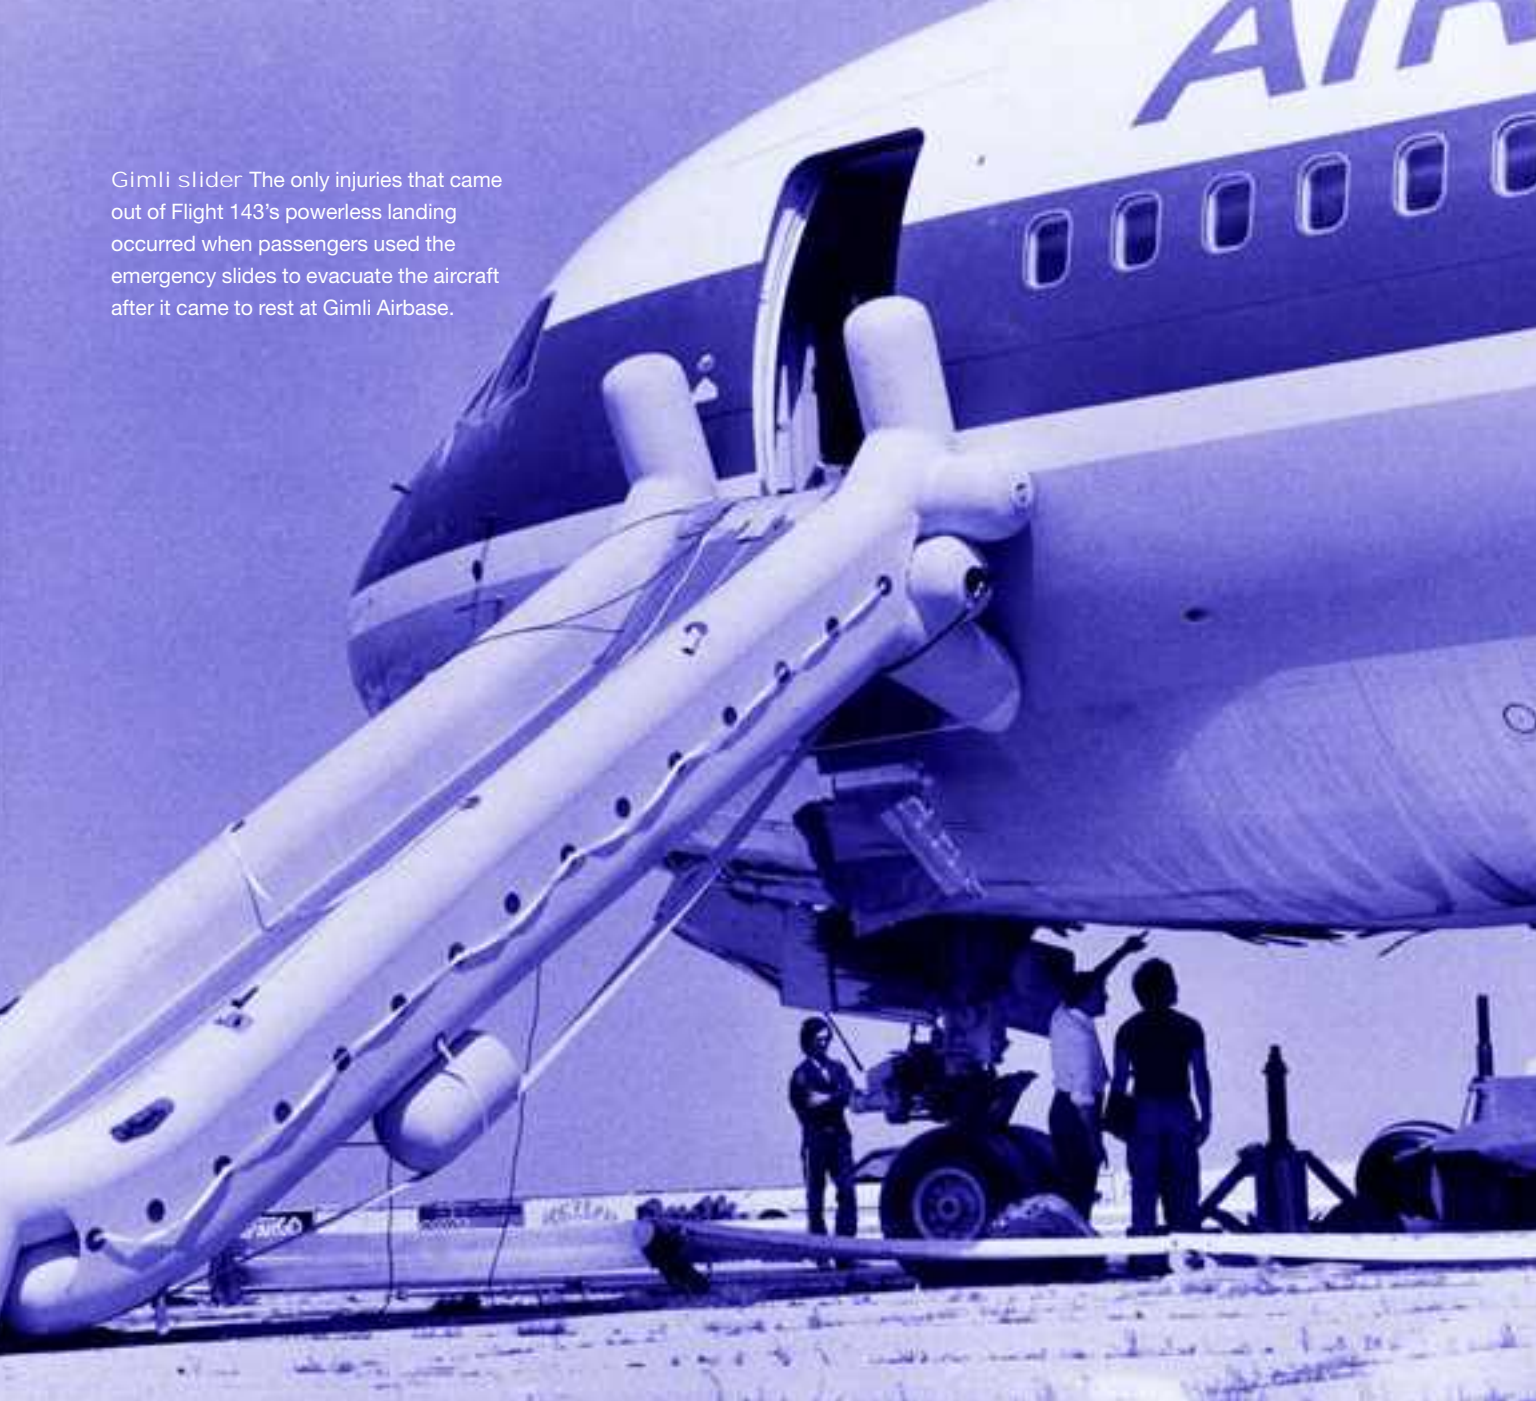
Gimli slider The only injuries that came out of Flight 143's powerless landing occurred when passengers used the emergency slides to evacuate the aircraft after it came to rest at Gimli Airbase.
